ADDRESS: 3905 Wisconsin St. Los Angeles CA 90037
LOT AREA: 4,294 SF (Narrow Lot - 38'x113')
APN: 5037-019-029

1. Conditional Use Permit for the new construction of a 3 bedroom Single Family Dwelling with Home Office Suite.

Kyle Onaga
3905 Wisconsin Street,
Los Angeles CA 90037

CASE NO.
ZA-2021-3075-ZAA-CU

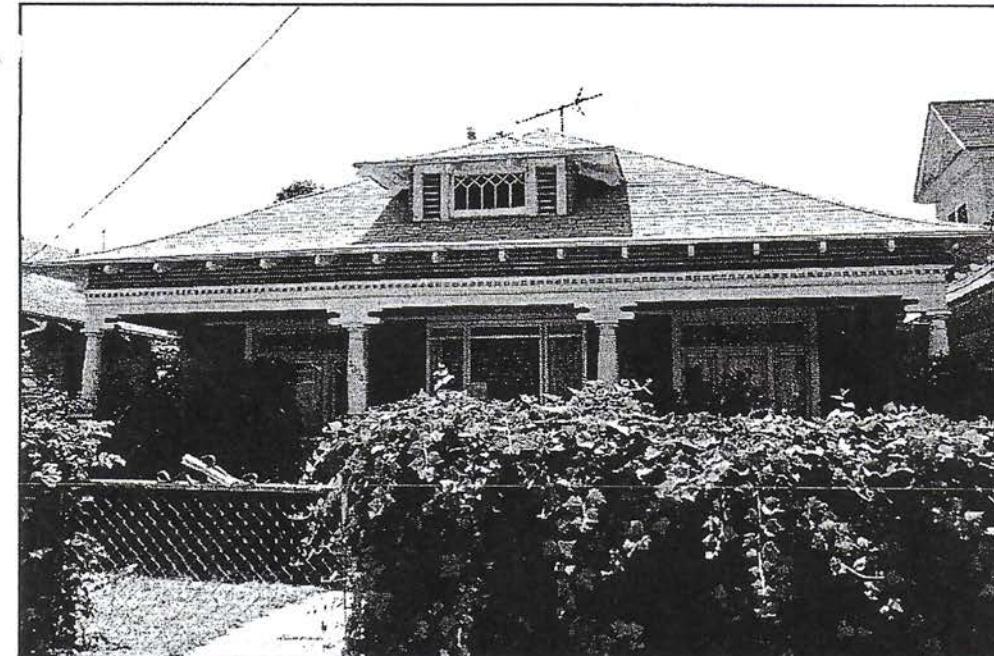
This Turn-of-the-Twentieth-Century cottage appears in good condition with no visible alterations since the property was last evaluated in the 1985 survey. Character defining features include the building's mass and scale, symmetry, hipped roof with center hipped dormer, exposed rafter tails, wood frame tripartite windows, recessed full-width front entry porch, and tapered Doric porch posts. Although the property does not appear to be individually eligible for listing in the National Register or California Register, it does appear eligible for individual listing as a City of Los Angeles Historic Cultural Monument as a very good and highly intact representative example of a Turn-of-the-Twentieth-Century cottage in the Exposition Park area.

P5b Description/Date of Photo: East elevation, looking west/July 2005

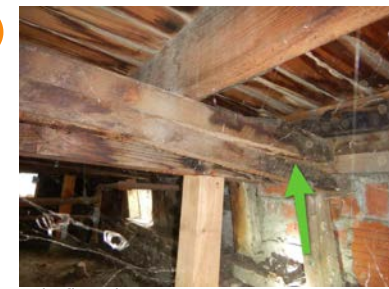
14.3.1 Floor Framing System

split floor beam

- ⊖
- 14.3.1 Foundation, Basement and Under-floor Areas - Floor Framing System : Damaged Wood floor framing
- ⊖ 14.3.2 Foundation, Basement and Under-floor Areas - Floor Framing System : Floor Framing Connections

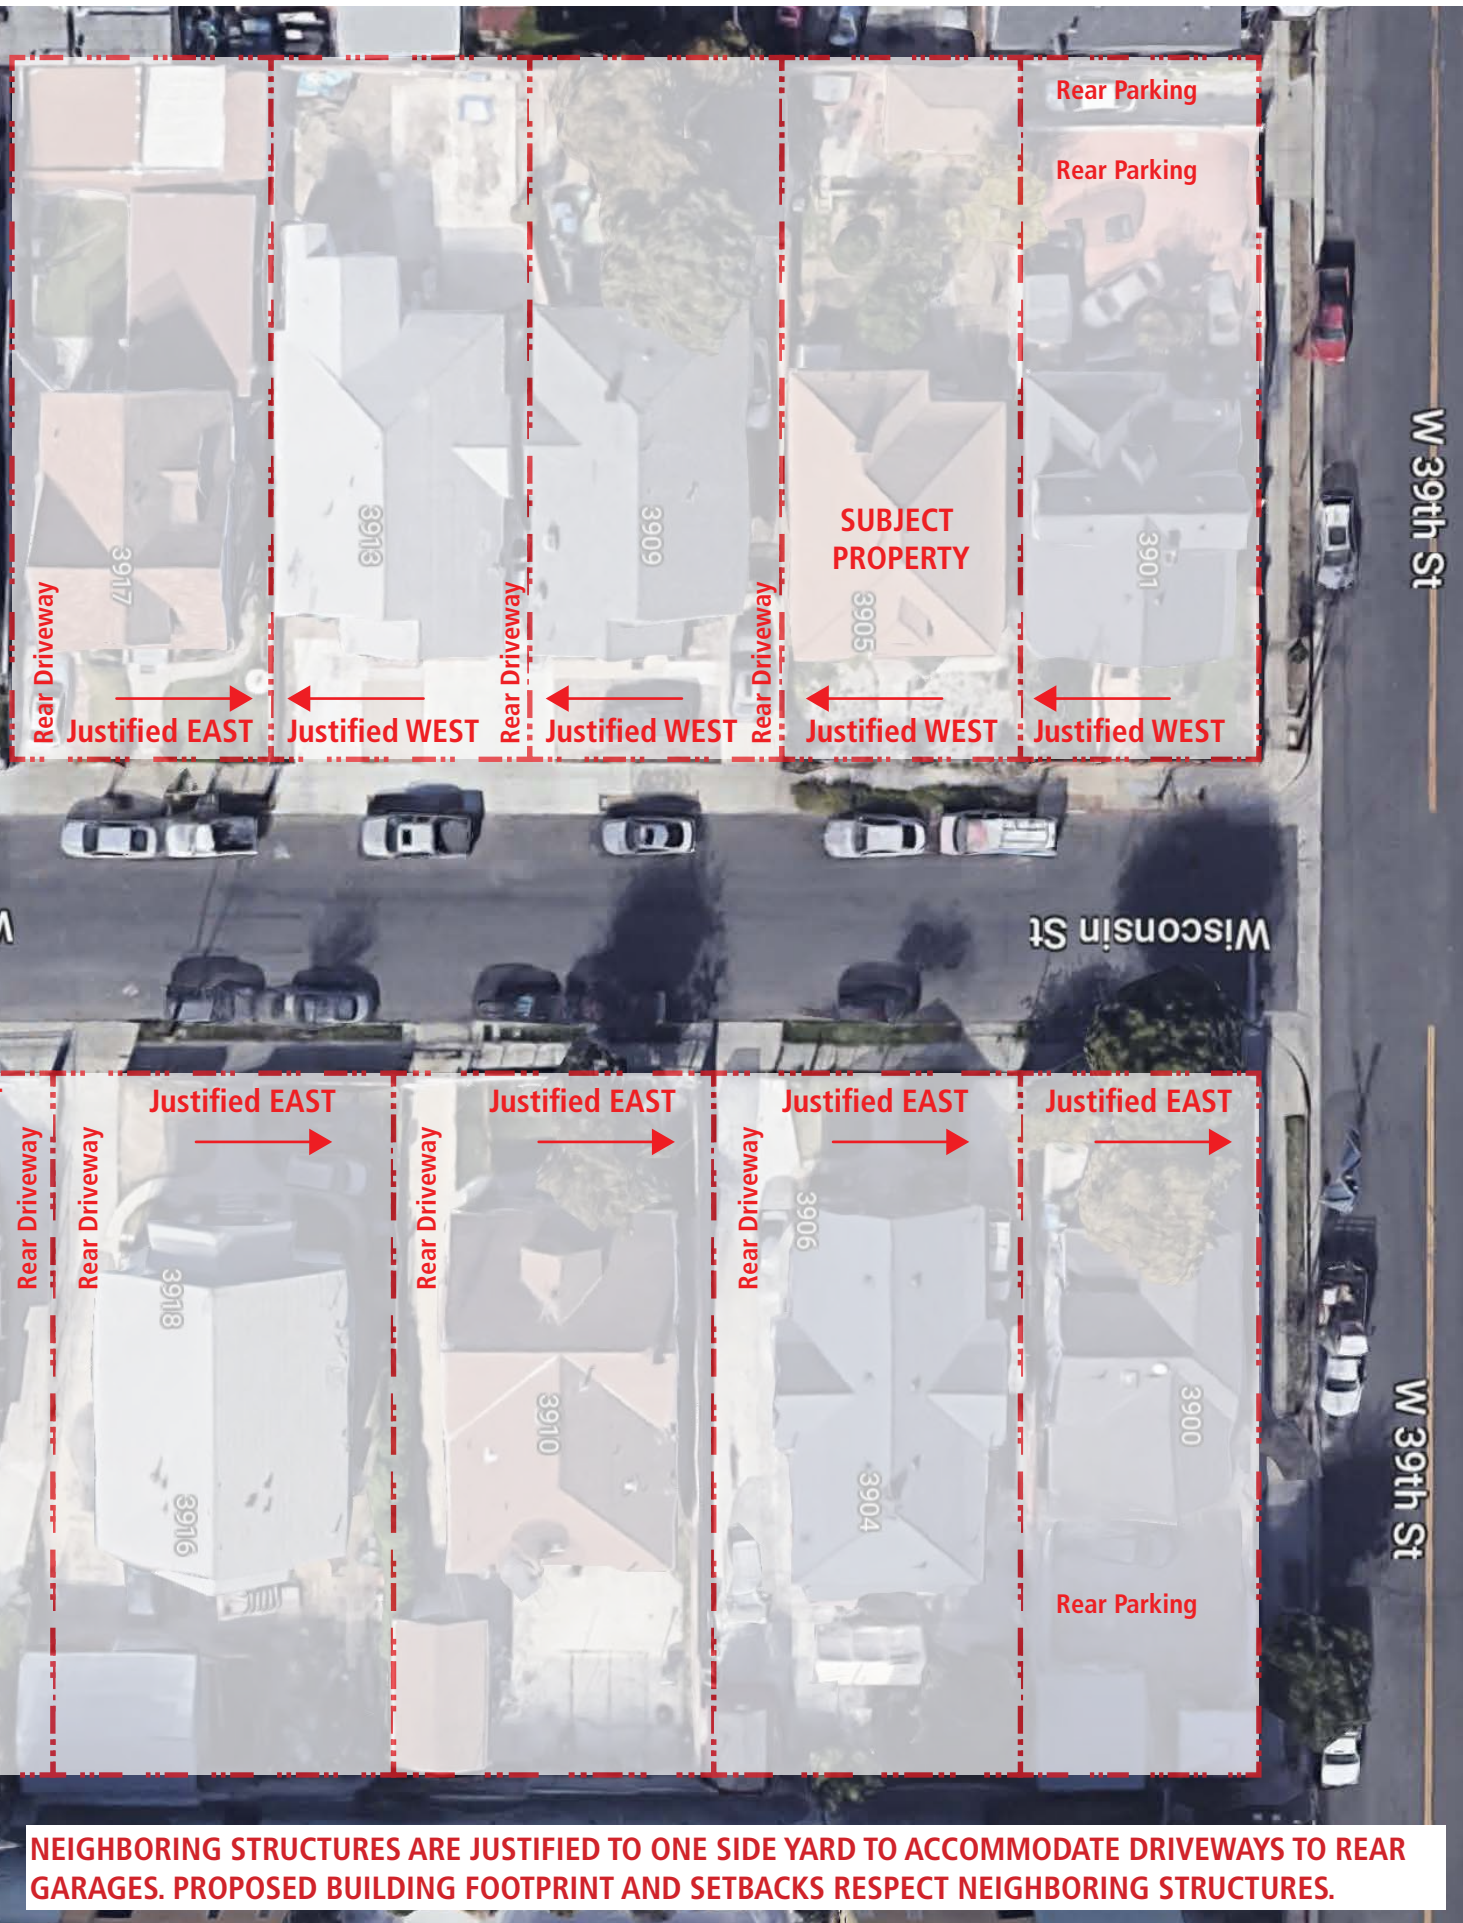
PROPOSED PARKING IN FRONT YARD SETBACK IS COMMONPLACE. IT WILL BENEFIT NEIGHBORHOOD NOT CONTRIBUTING TO STREET PARKING SHORTAGE CREATED BY NEIGHBORING DEVELOPMENTS.

3. Zoning Administrator’s Adjustment to permit one uncovered parking space within the front yard setback.

LAMC Section 12.21-C,1(g)

No automobile parking space shall be provided or maintained within a required front yard. Except where a lot is developed with a building meeting the requirements of Section 12.08.3B1. not more than 50% of a required front yard shall be designed, improved or used for access driveways.

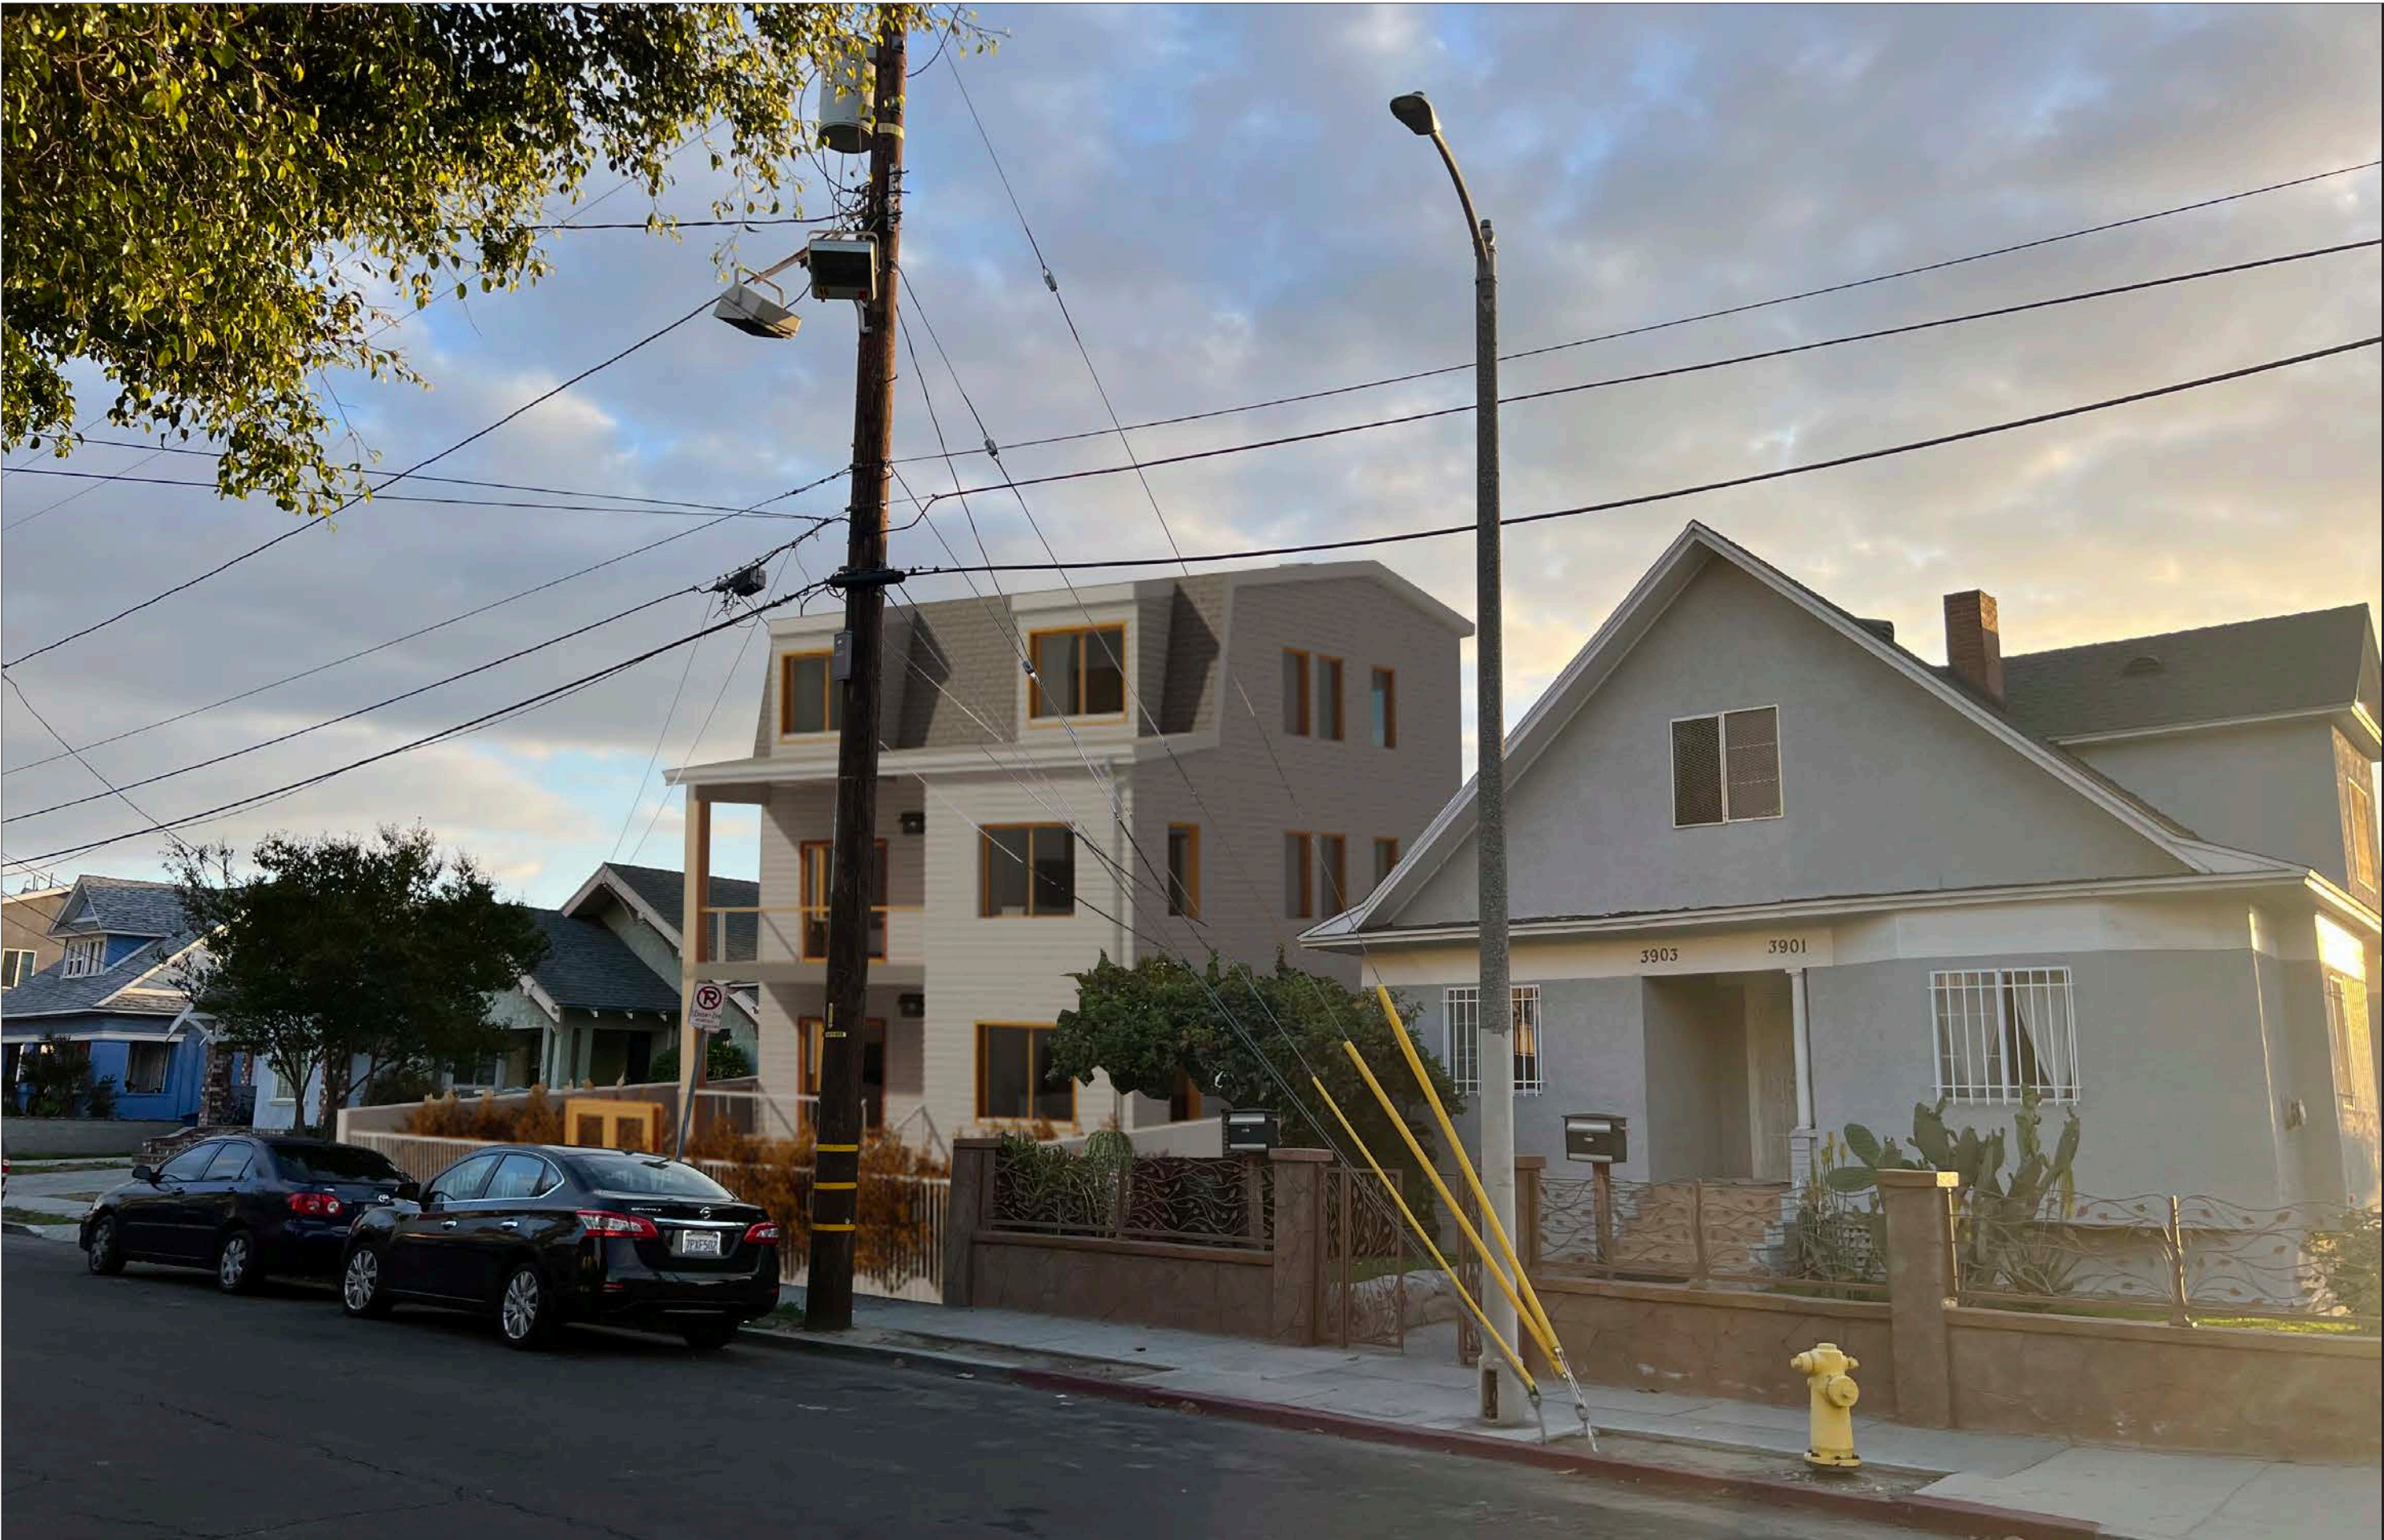
NEIGHBORING STRUCTURES ARE JUSTIFIED TO ONE SIDE YARD TO ACCOMMODATE DRIVEWAYS TO REAR GARAGES. PROPOSED BUILDING FOOTPRINT AND SETBACKS RESPECT NEIGHBORING STRUCTURES.

2. Zoning Administrator’s Adjustment to permit a 3’-0” side yard setback in lieu of the 4.8’.

LAMC Section 12.09.1,B,2(a)

10% of lot width where lot is less than <50 ft wide; +1ft for each story over 2nd.
